# Using Acoustic Emission to Detect HRSG Tube Cracks

2015 HRSG User's Group Conference  
March 09-11 – Orlando-FL

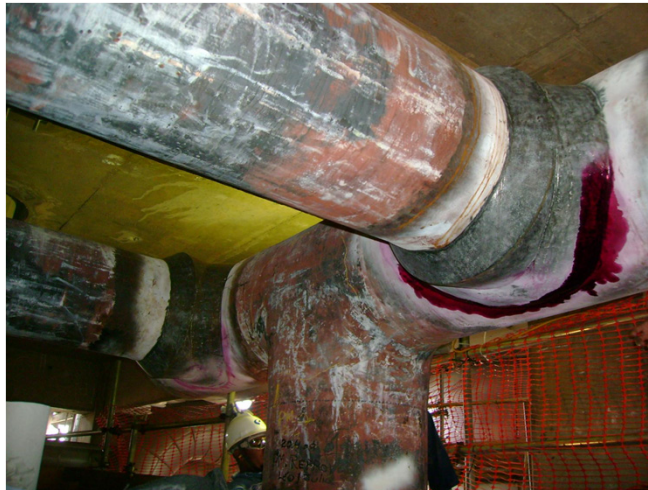
Creep Fatigue cracks in steam piping

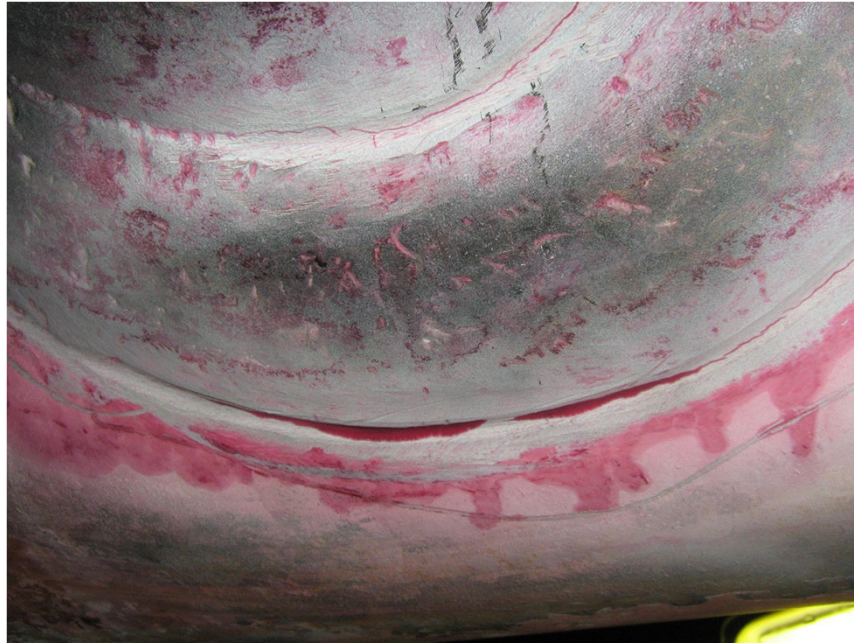
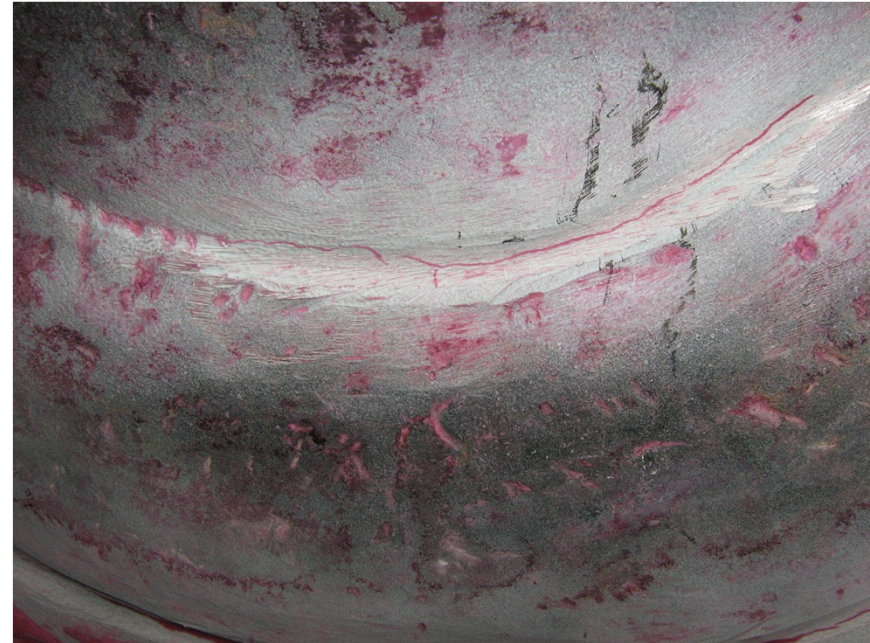
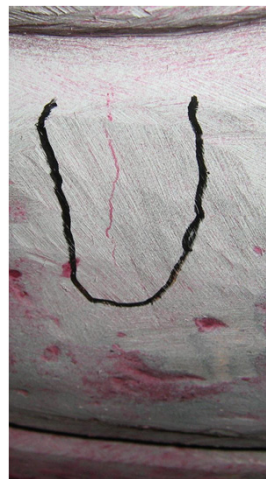
Creep Fatigue cracks in  
steam piping

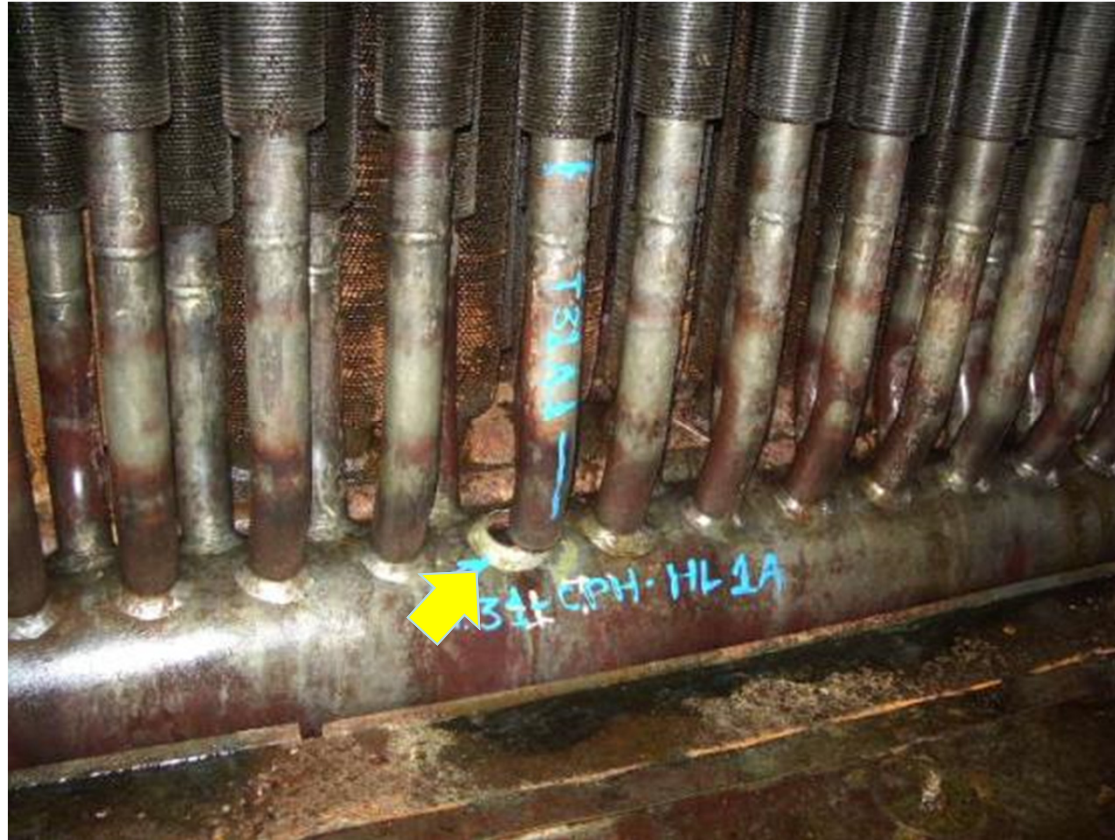
## Low cycle fatigue cracks

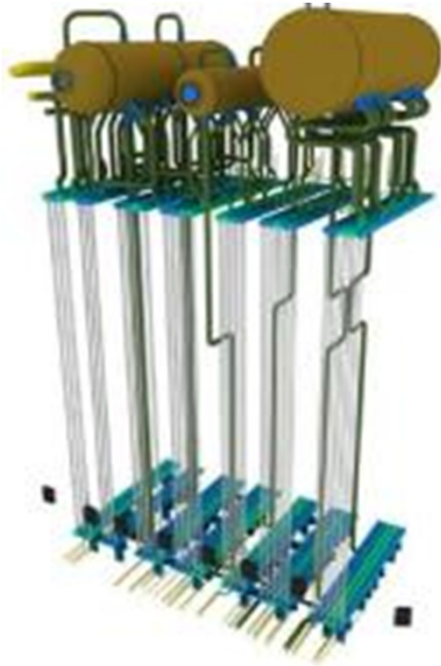
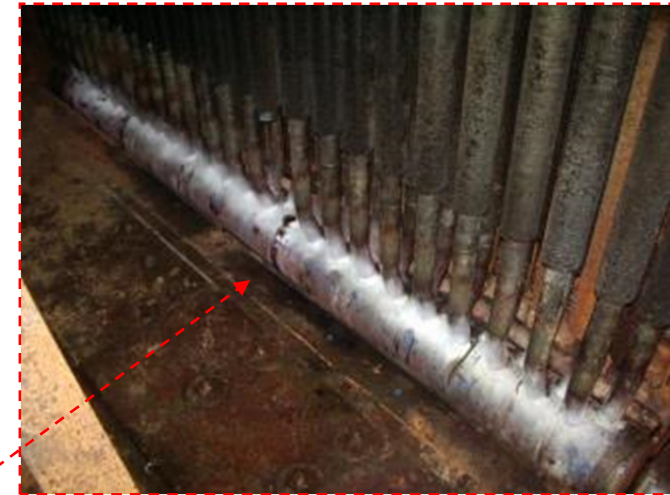
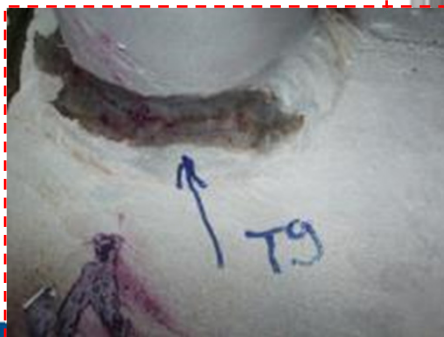
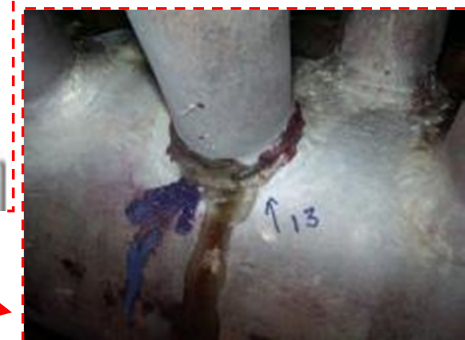
Low cycle fatigue cracks

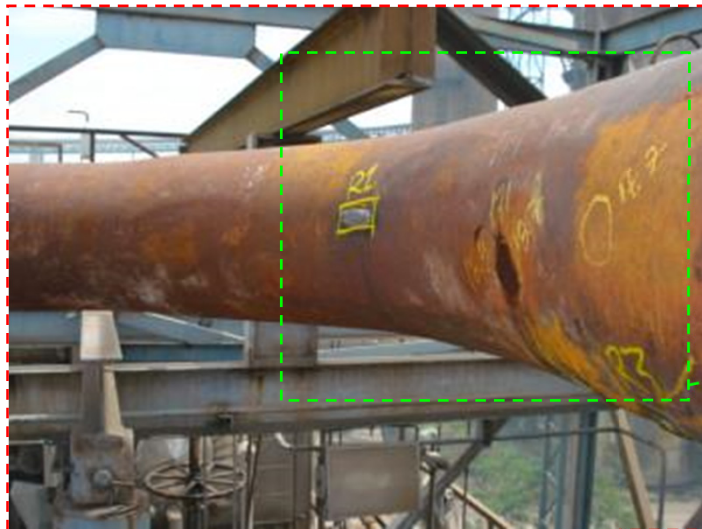
BEND OF THE DESSUPERHEATER

Thermal fatigue cracks in ext piping

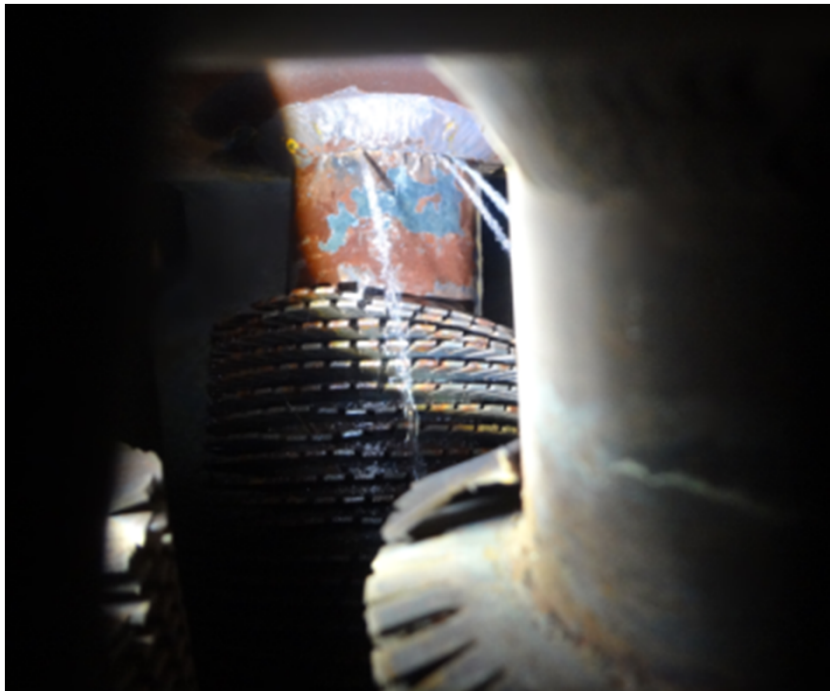
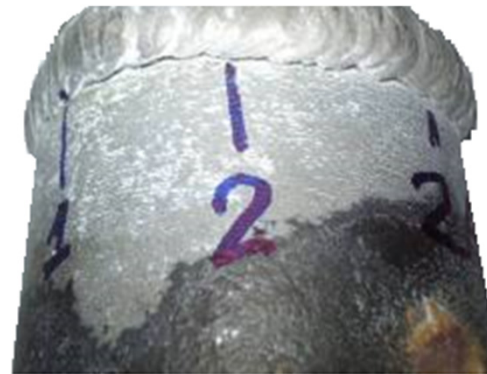
Thermal Fatigue cracks at tube/header connections “before they leak”

5.7mm

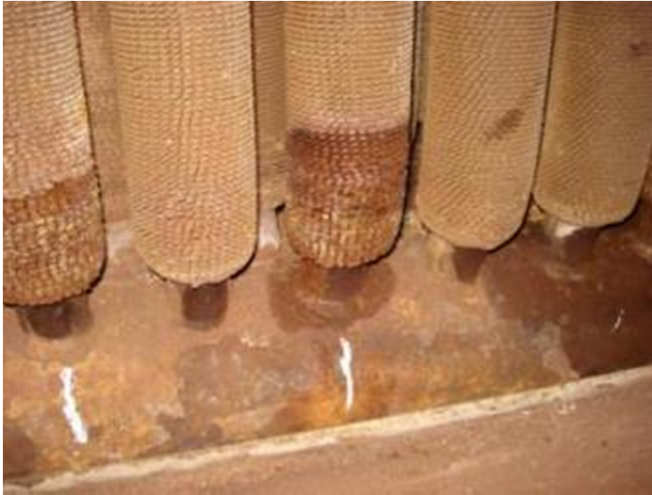
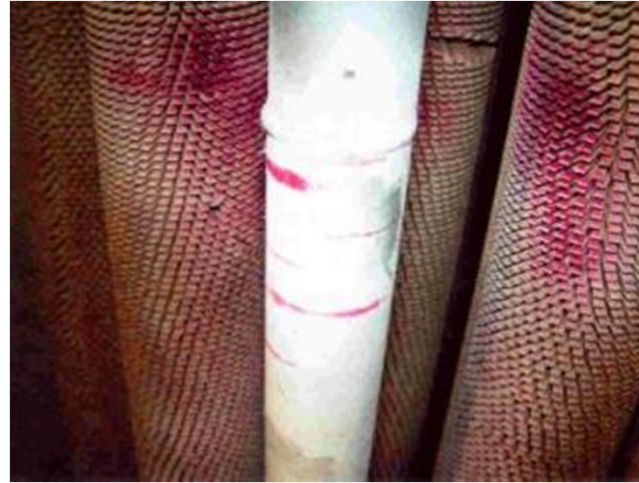
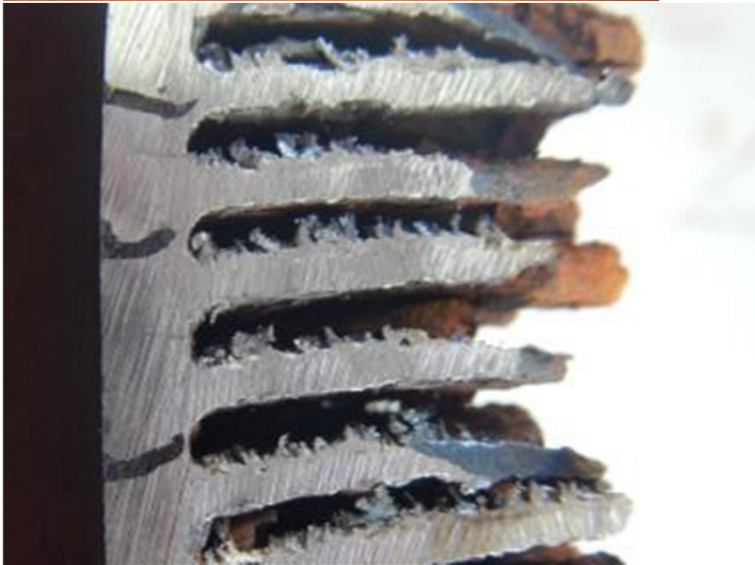
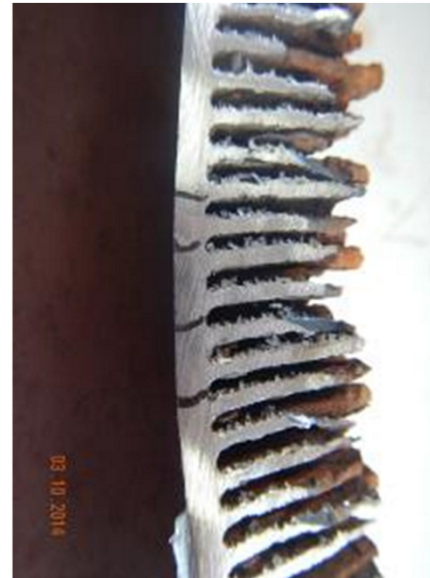
Dew point  
SCC cracks

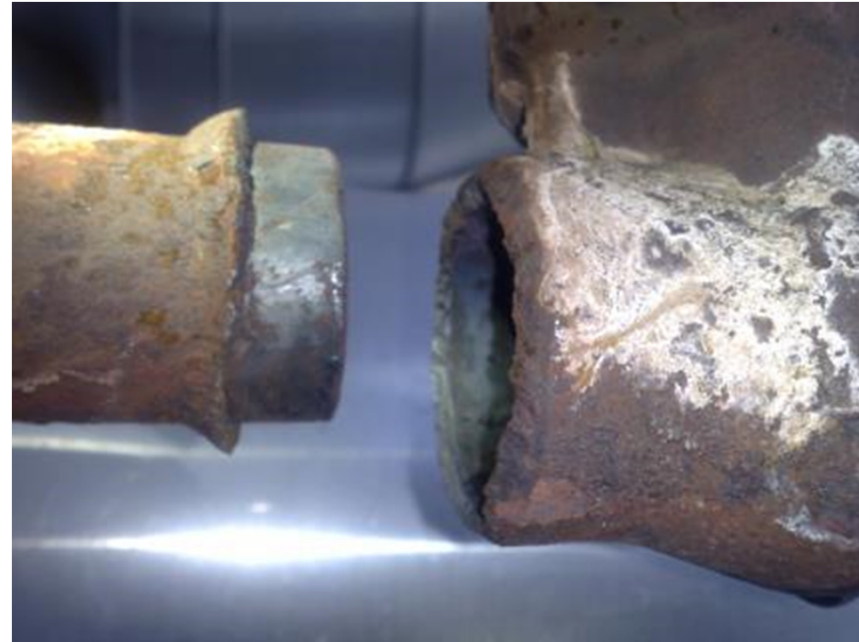
Fatigue

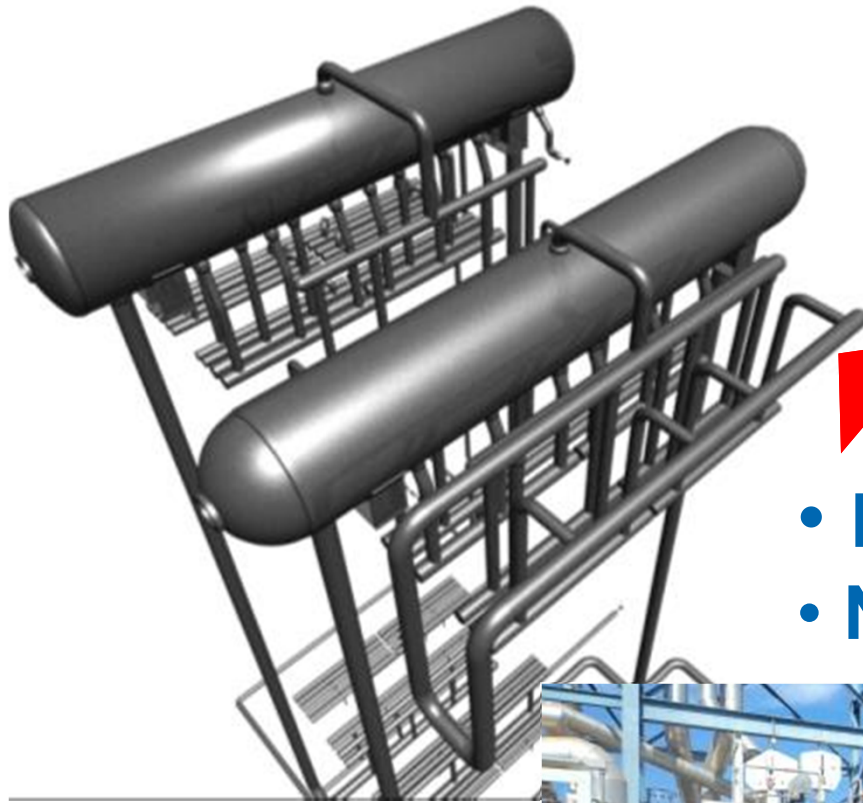
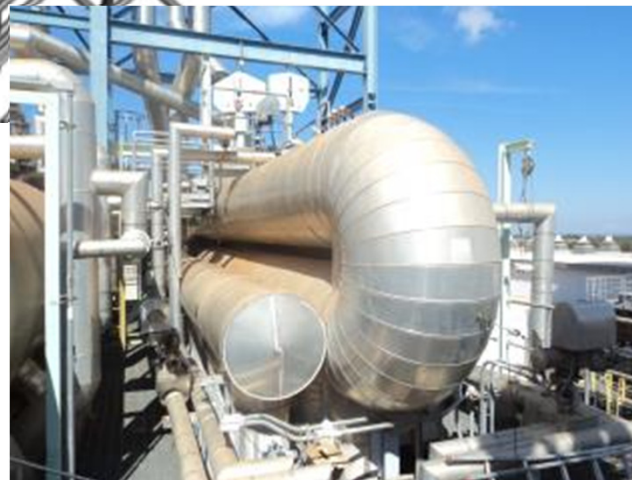
- External thermal insulation
- No access (scaffold needed)

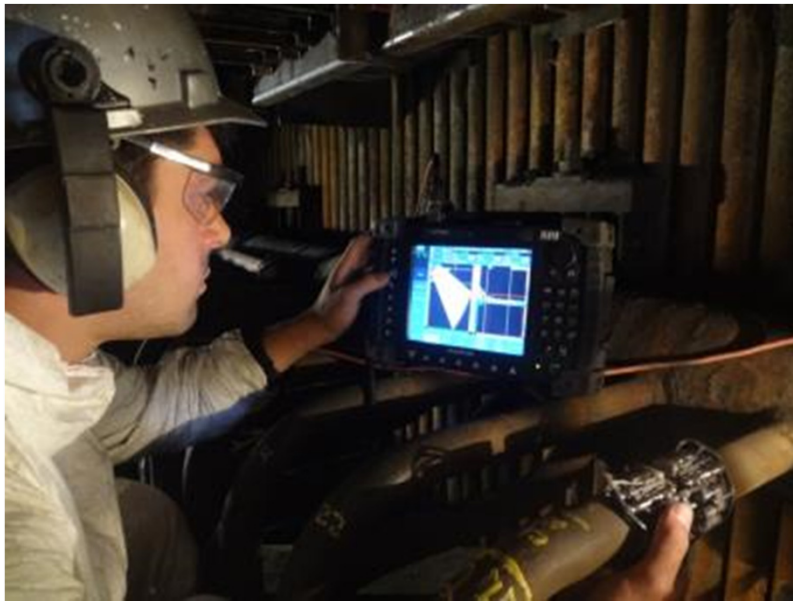
# PA/ET applied to “AE flagged” area during outage

**Phased Array**

5.7mm

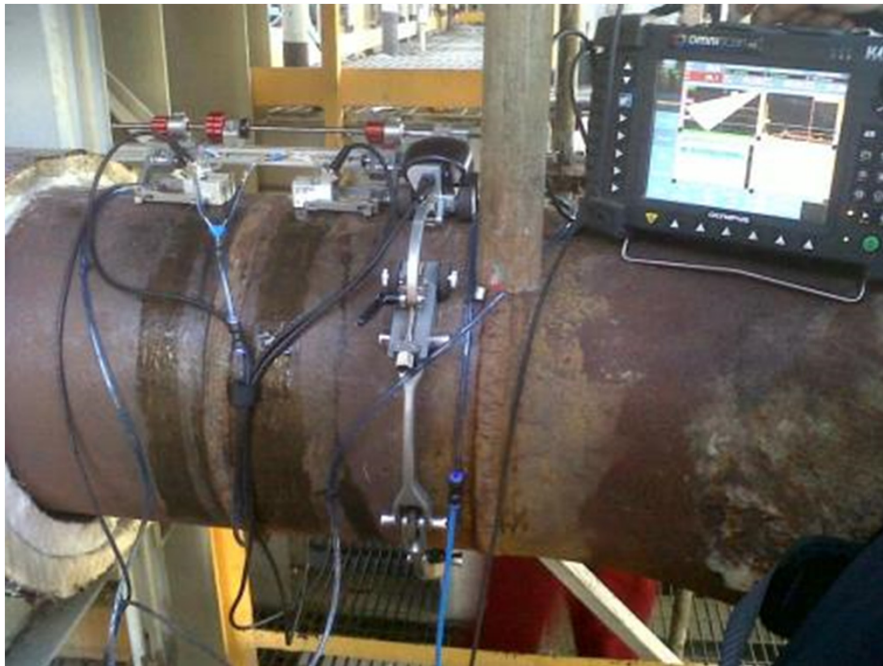
# PA/ET applied to “AE flagged” area during outage

Phased Array

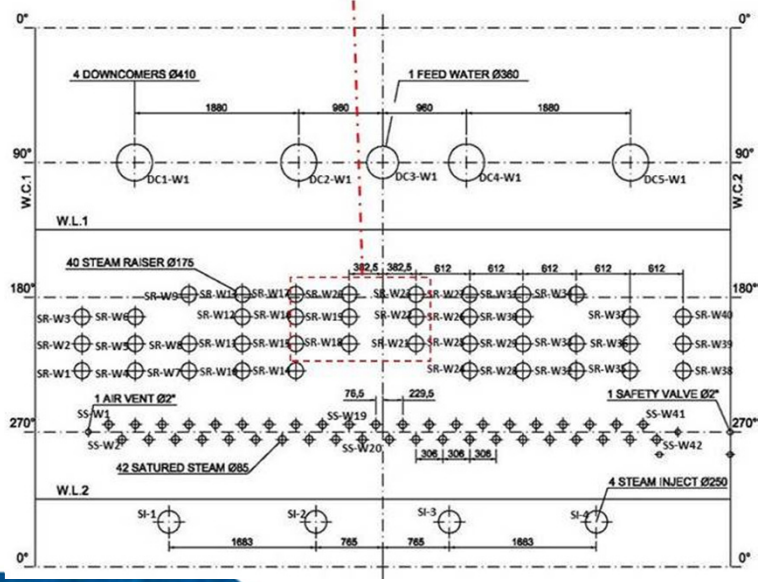
Drum

# PA/ET applied to "AE flagged" area during outage
